THE RUNAWAY SOURCEHEAD

A 2800 pound sourcehead of a radiation teletherapy device fell suddenly and fatally injured a patient. Was this accident caused by defective mechanical design, inadequate maintenance, improper operation, or some combination of the above?

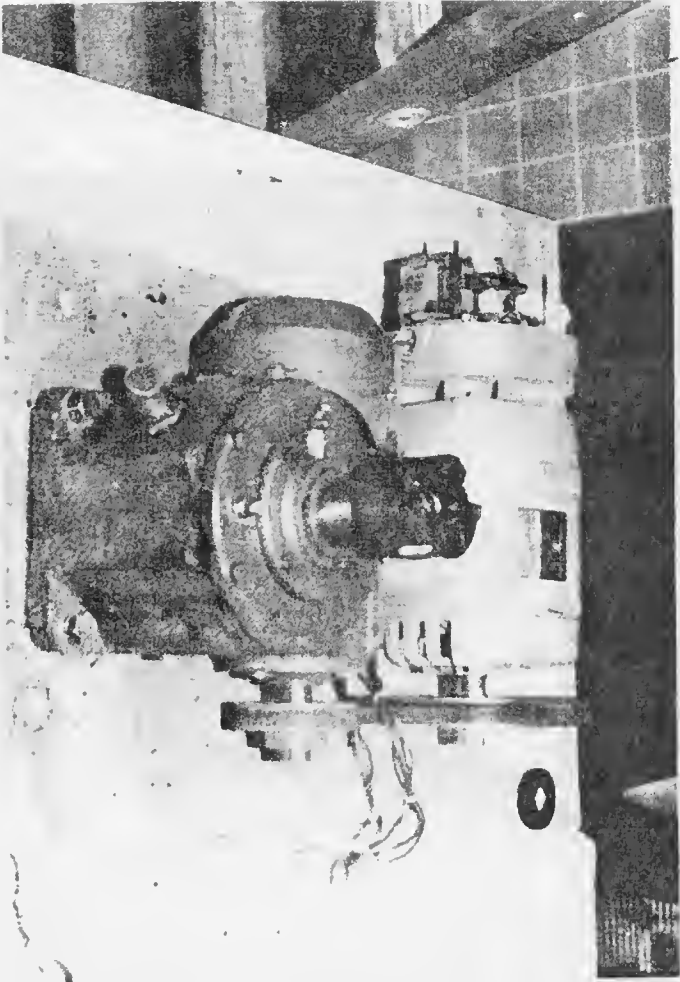
Exhibit 7 Reducer with Coupling

Results showed that two setscrews in the upper half of a coupling in the drive system of the unit did not prevent the coupling from moving up the shaft end and disengaging from its lower half. This allowed the shaft (ball screw) to spin freely. The head and carriage ride up and down on the ball screw shaft as it turns, and thus was allowed to fall essentially unimpeded. There was no system for preventing uncontrolled descent in the event of the failure of this coupling. Additional damage to the other parts of the device occurred during the fall of the head and after its impact.

Evidence shows that at least one of the two setscrews was never tightened, and that both setscrews were loose at the time of the incident. Evidence does not clearly show whether the second setscrew was never tightened or whether it was tightened and worked loose.

The cause of the accident was the failure of the coupling halves to stay engaged. The upper half of the coupling was not secured in place by the setscrews and was allowed to work up the shaft. When the teeth disengaged from the teeth of the lower coupling, the ball screw shaft was allowed to spin freely under the weight of the sourcehead and carriage. This allowed the sourcehead and carriage to fall.

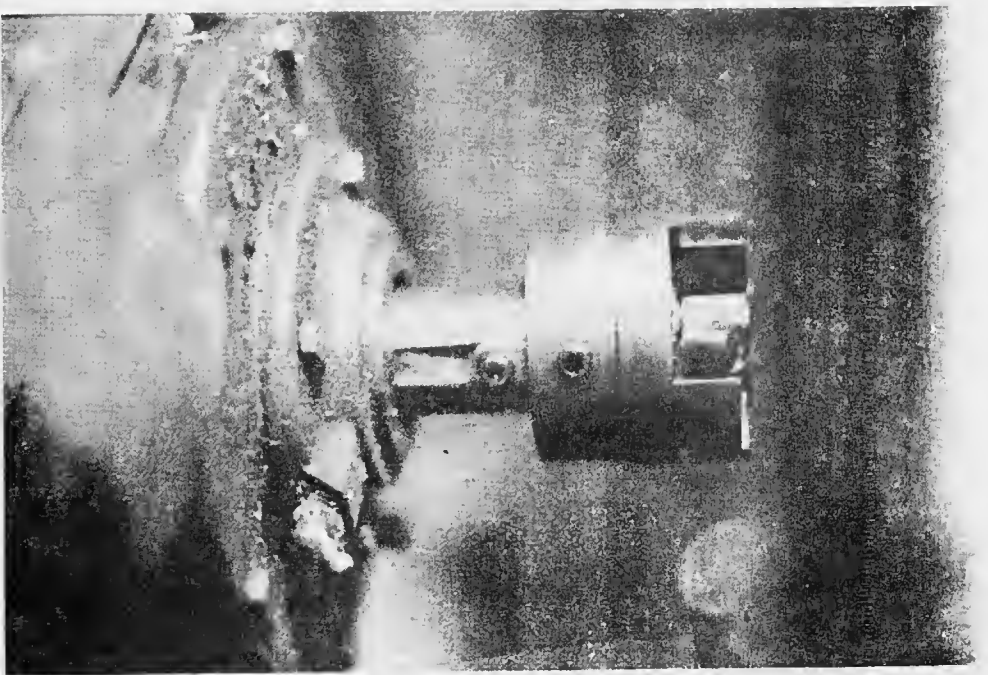
Exhibit 8 Lower Half of Coupling with Spider

Examination of the lower half of the coupling, which had not failed but was slightly displaced downward, showed that the two setscrews corresponding to those in the upper coupling were less than finger tight (8 inch-ounces and 10 inch-pounds). It is not known if the setscrews were loose before the incident or as a result of the incident. The third setscrew was designed to be threaded through the key into the shaft and was found to be cut off short, serving no purpose.
